Manhole Inspection Summary

Manhole # S21I2001MH

Location Address: **1108 BRYN MAWR RD** Cross Street: **HARRINGTON RD**

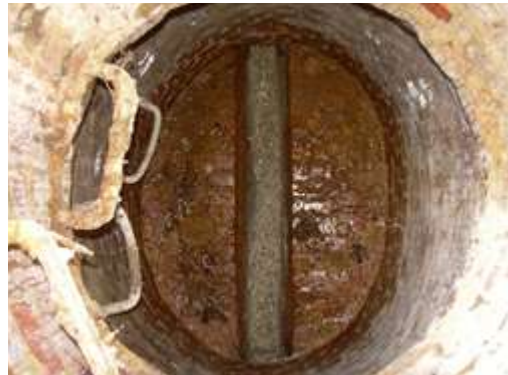
Top View

Evidence of surcharge - Bench debris.

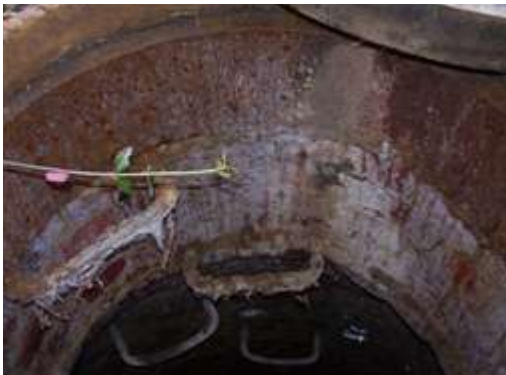
Defect

Chimney / Frame Adjustment ☒ Exists Material: **Brick** ☐ Parged Height: **15** (in.)
Condition: ☐ Sound ☐ Cracked ☐ Root Intrusion ☐ Loose Brick ☒ **Deteriorated**
Infiltration: ☐ None ☒ **Joint** ☐ Cracks ☐ Mortar ☐ Roots ☒ **Wall**

Adjustment deterioration and infiltration.
Barrel infiltration - other side.

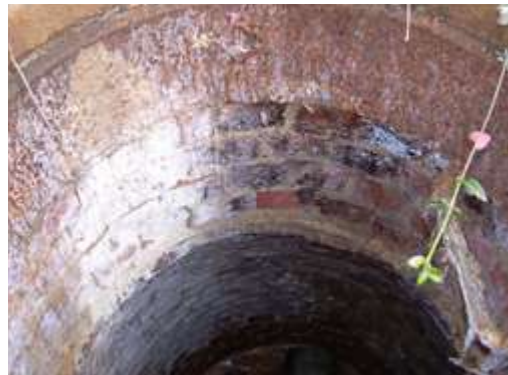
Defect

Barrel Material: **Brick** ☐ Parged
Shape: **Circular** Diameter: **42** (in.) Length: (in.)
Condition: ☒ Sound ☐ Cracked ☐ Root Intrusion ☐ Loose Brick ☐ Deteriorated
Infiltration: ☐ None ☐ Joint ☐ Cracks ☐ Mortar ☐ Roots ☒ **Wall**

Adjustment deterioration and infiltration.
Barrel infiltration.
